Comparative study on borehole images of BIPS and FVCS

Outline of the presentation

To examine the applicability of FVCS in the fracture analysis in borehole.

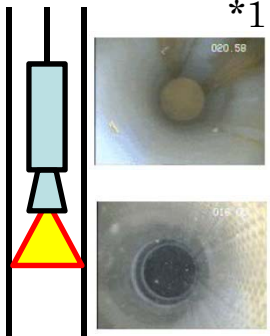
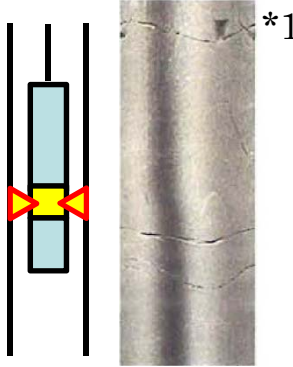
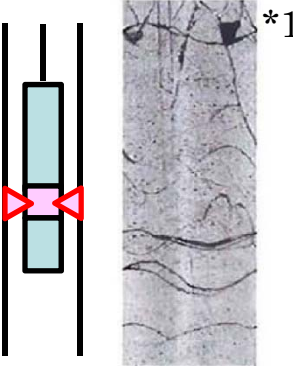
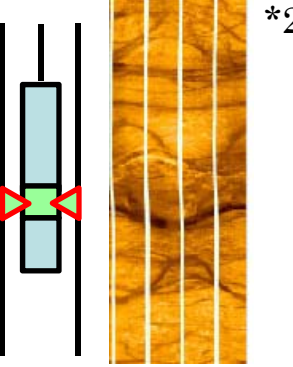
Introduction.....Tools for borehole imaging

No	1	2	3	4	5
Typical System	Impression Packer	FVCS Forward Vision Camera System	BIPS(ODS) Borehole Image Processing System	BIPS(USS) Borehole Image Processing System	FMI or FMS Fullbore Formation Micro-Imager
Measuring mechanism	Fracture tracing by rubber and inflation packer.	Optical downhole view.	Imaging by horizontal optical view.	Imaging by ultrasonic beam reflection.	Imaging by electric resistivity.
Sketch of equipment and data

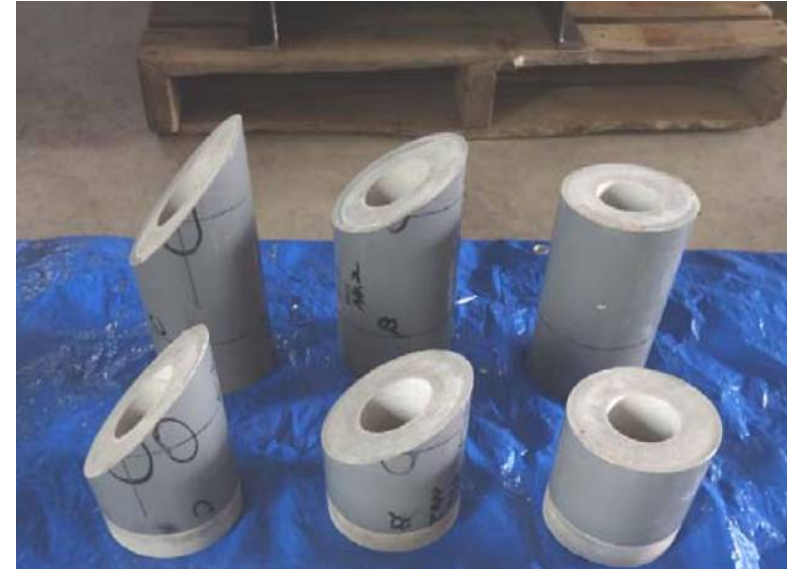
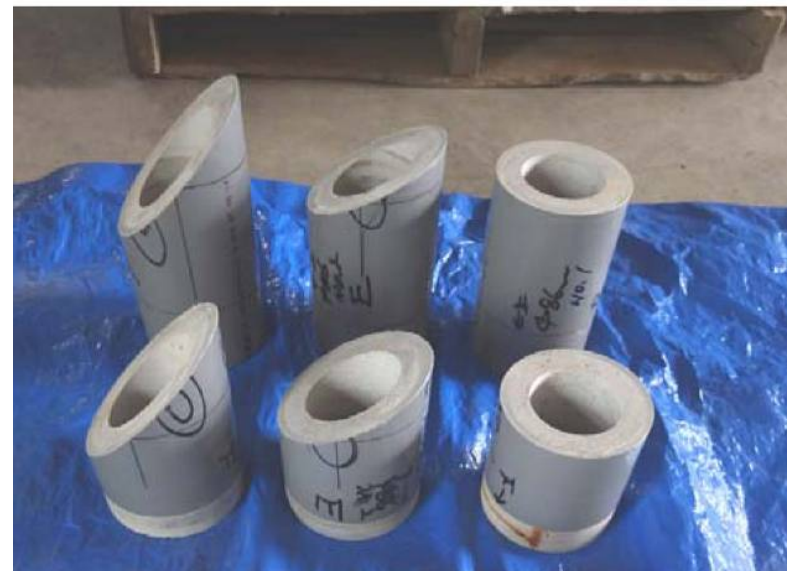
Test pieces used in the measurement

The measurement were performed with changing the borehole diameter , the dip angle of a fracture, the width of a fracture and the camera position.

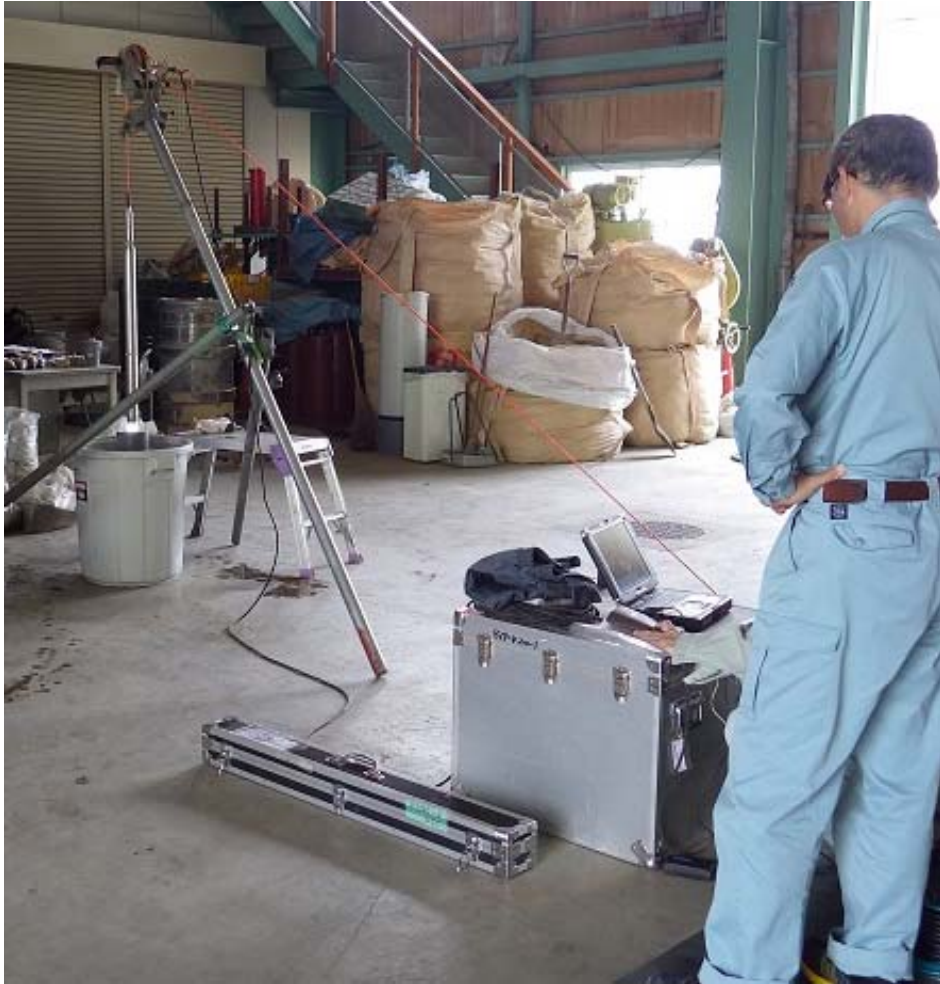
Photographs of measuring operation

Monitor and depth sensor

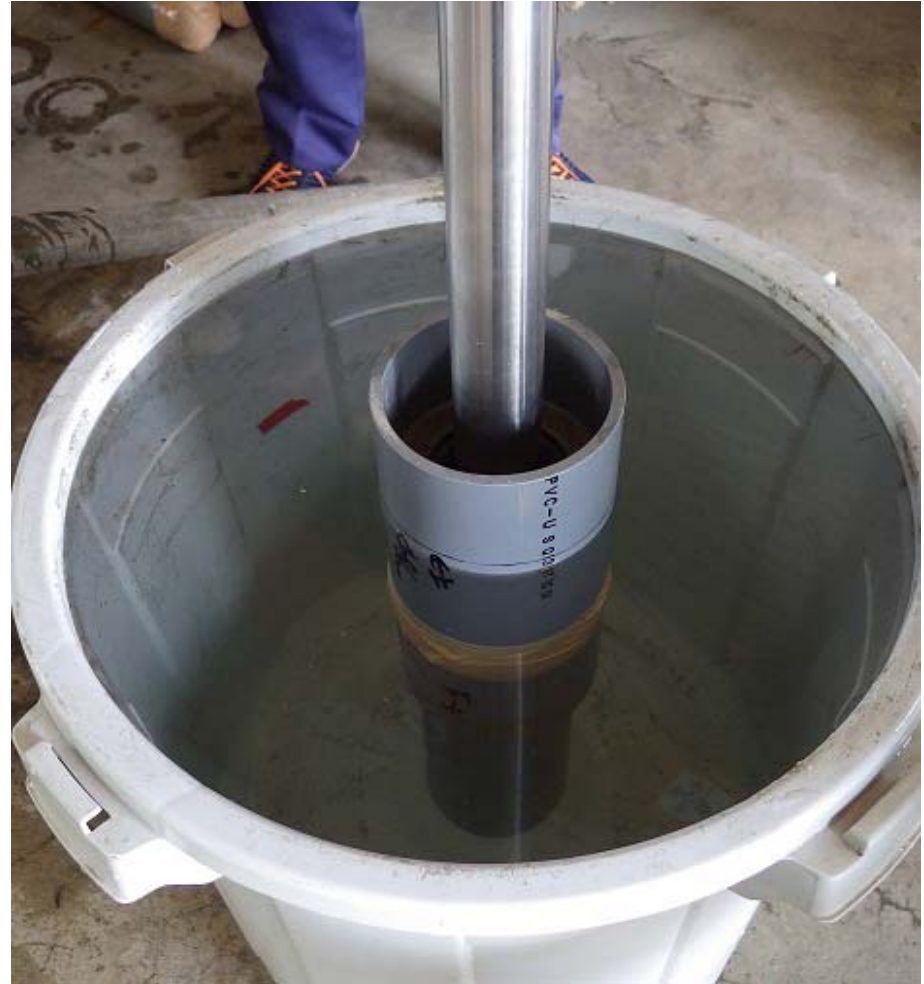
Test piece and measuring

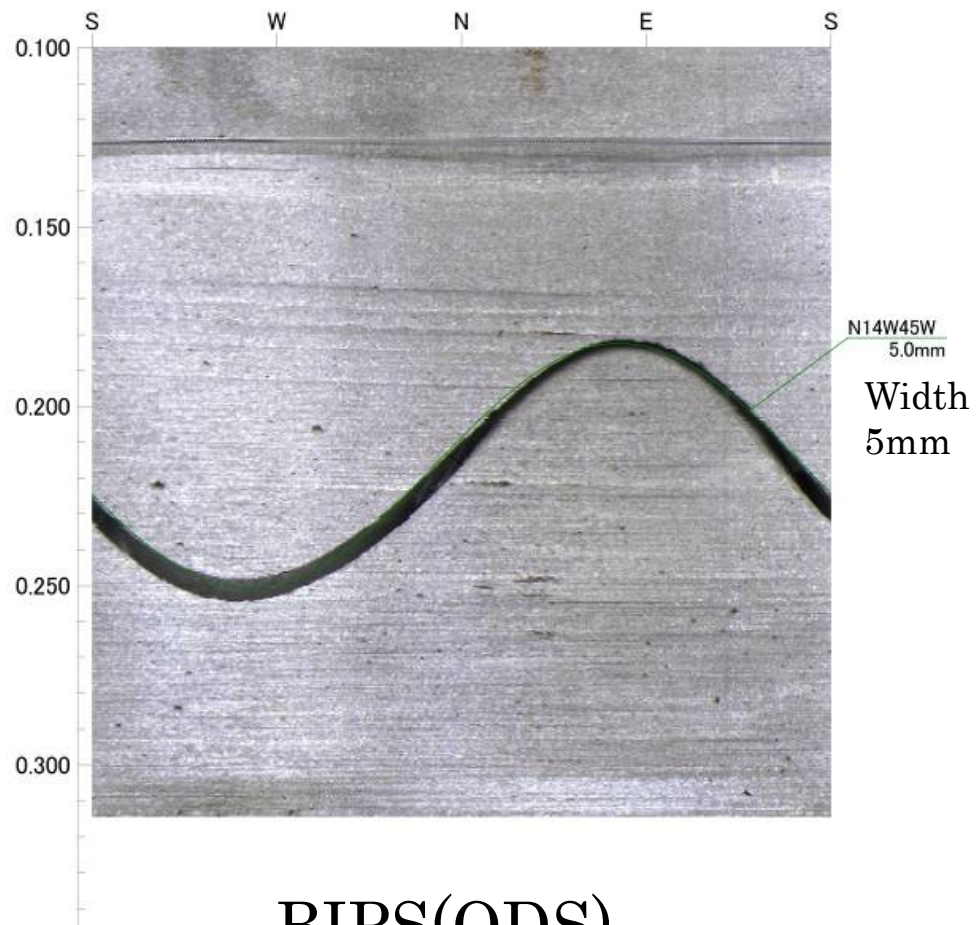
BIPS(ODS)

Result of imaging

Fracture : 45 degree dipping
(width=5mm)

Camera position : center
